# **CITY OF SOUTH ST. PAUL**

## **Memorial Library Reuse**

### **Feasibility Study**

CONDITION ASSESSEMENTS

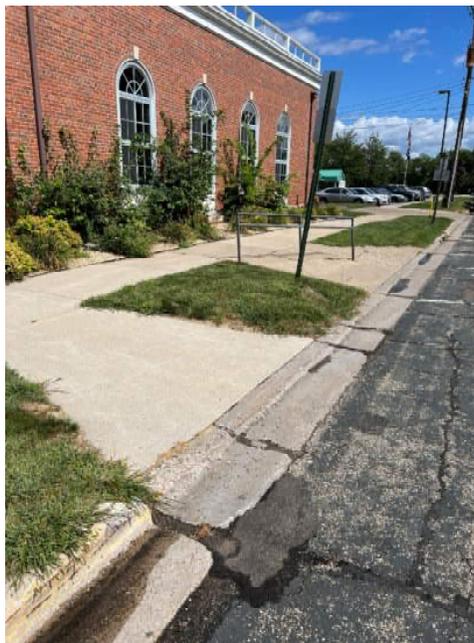
The existing pavement along Marie Avenue is in acceptable condition. The existing pavement appears to have been sealed at some point in the recent past but is now exhibiting minor cracking across the roadway with worse cracking around manhole and storm inlet structures. However, there do not appear to be any potholes or major cracks that would result in substandard driving conditions. Marie Avenue to the west of Third Avenue North is proposed to be improved significantly with the addition of modified on-street parking and a bike lane. Figure 1 shows the general condition of the existing asphalt throughout Marie Avenue south of the library.

**Figure 1: Typical Condition of Existing Pavement in Marie Avenue**

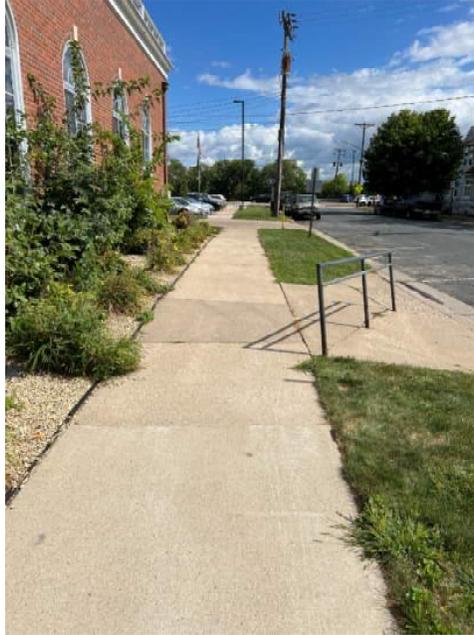
The existing sidewalks along Marie Avenue to the south of the library appear to be in acceptable condition. There do not appear to be any significant gaps that would impact ADA accessibility nor are

there any apparent cracks in the sidewalk panels. The image below shows the general sidewalk condition along Marie Avenue to the south of the library. There is an existing on-street ADA parking stall located immediately south of the library. The stall is accessed by an ADA ramp and handrail that leads up to the existing sidewalk. By visual inspection, it did not appear that this parking stall meets the current ADA requirements.

**Figure 2: Typical Sidewalk Condition Along Marie Avenue**

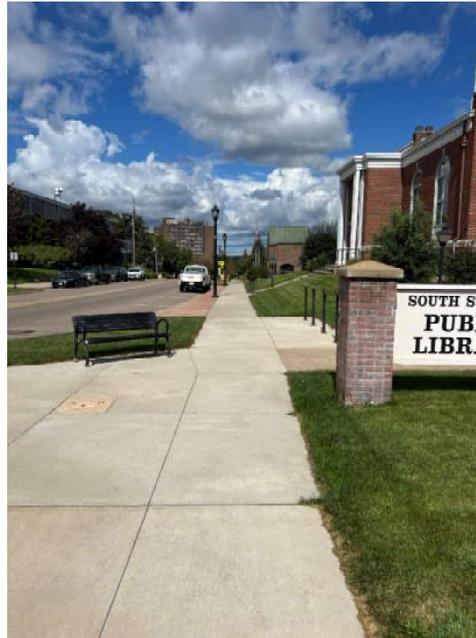
The existing pavement, sidewalk, and curb and gutter condition along Third Avenue North appear to be in acceptable condition. ADA ramps at the intersection of Third Avenue North and Marie Avenue are present and appear to meet ADA requirements based upon a preliminary visual inspection. Lastly, bicycle parking is located off the sidewalk near the intersection of Marie Avenue. On-street parking is located on Third Avenue North immediately in front of the existing library. The image below shows the general condition of the existing pavement and sidewalk along Third Avenue North.

**Figure 3: Existing Pavement and Sidewalk Condition along Third Avenue North**

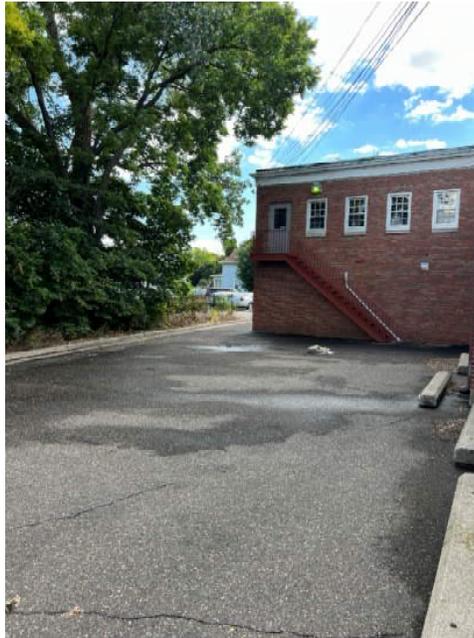
The existing pavement in the library's rear parking area appears to be in acceptable condition. There are some existing cracks along the northwest corner of the paved area along the existing curb and gutter line. The asphalt cracking may be a result of poor stormwater drainage and/or issues with the asphalt's subbase.

**Figure 4: Existing Pavement Condition in Rear Parking Area**

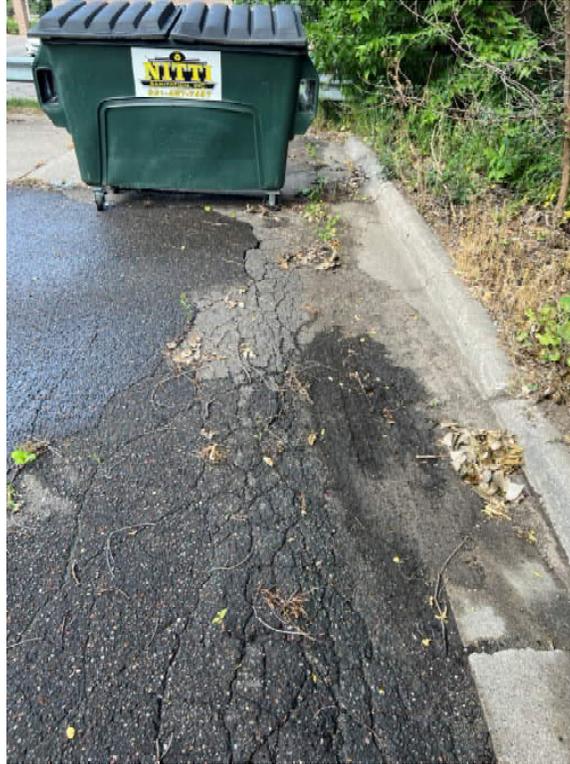
The rear parking area appears to generally slope to the northwest corner where stormwater then flows onto an asphalt path where it then flows onto the existing parking lot north of the library. There may be issues with the stormwater management through this area of the parcel. During heavy rainfall events, it seems likely that stormwater is channeled around the existing gutter line at the east edge of the paved area and then eventually flows into the parking lots to the north or down the adjacent slope. This uncontrolled stormwater flow could impact the slope's stability and could also be impacting the integrity of the existing asphalt. Figure 5 documents some cracking that was observed in the asphalt within this area. It is also possible that the existing asphalt pavement section is not suitably strong enough to withstand the frequent loadings from garbage trucks accessing the trash container.

**Figure 5: Asphalt Cracking Observed in NE Corner of Rear Parking Area**

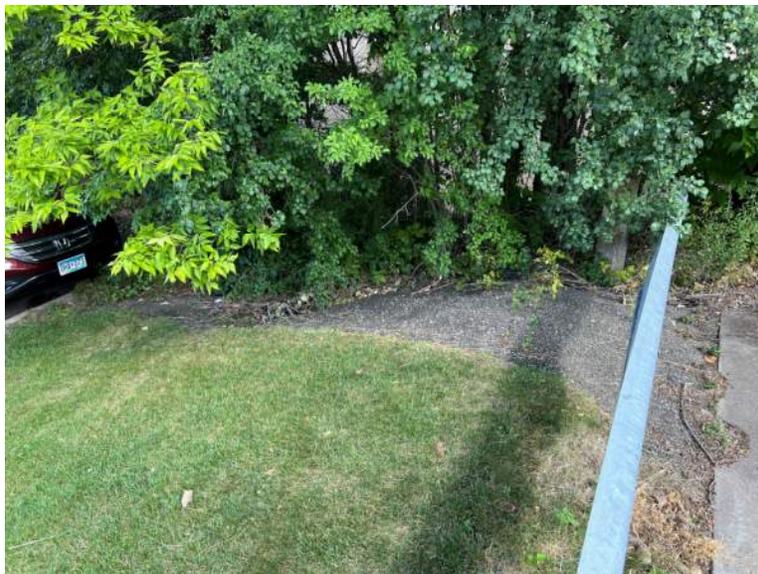
Figure 6 shows the current paved chute that conveys stormwater from the rear parking area down to the parking lot to the north. This paved chute does not control the stormwater nor does it prevent it from spilling down the existing bluff.

**Figure 6: Existing Stormwater Conveyance Path from Rear Parking Area to North Lot**

In order to better control stormwater flowing from the rear parking area to the north lot, a catch basin and piped outfall to the north parking lot or connection to the existing storm infrastructure further north in the north parking lot may be required.

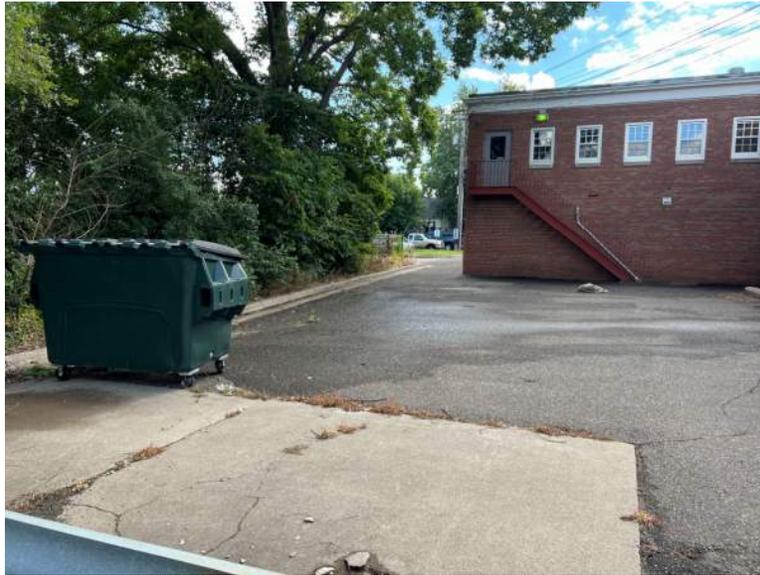
Lastly, the rear parking area is currently being used to stage the trash containers that serve the library. The access to the rear parking area is very narrow with limited clearance on either side. Garbage trucks have historically been able to access the trash container. However, there are no protections for the existing building corner and there is an adjacent steep slope just beyond the existing curb line. There do not appear to be any other suitable trash staging locations on the parcel that could remedy this limited access.

**Figure 7: Current Trash Staging and Access**

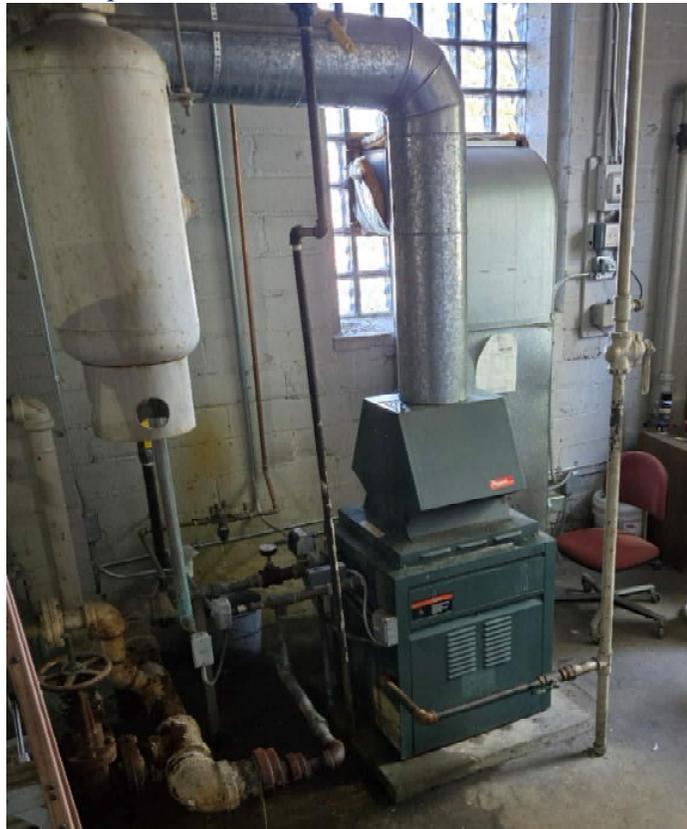
*Figure 8: Gas Fired Boiler*

This boiler is approximately 30 years old. The average life expectancy of a boiler is 15-20 years. Due to its age, it is recommended to be replaced if hot water is to be utilized for future HVAC systems.

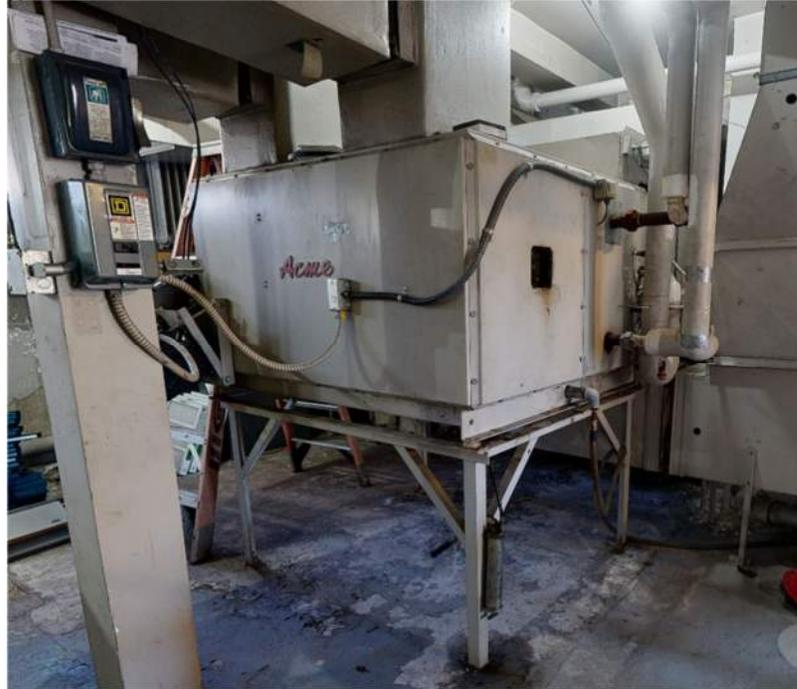
***Figure 9: Indoor Air Handling Unit***

This air handling unit serves the original 1927 portion of the building, and its age was unable to be determined. Based on visual inspection of the equipment, it looks like various parts and pieces have been

replaced over the years, but this unit would not comply with current required equipment efficiencies per the 2024 MN Energy Code.

The ages of the hot water coil and roof mounted DX unit are unknown. Due to the existing condition of the AHU and DX unit it is recommended to replace these pieces of equipment if the existing ductwork is going to be re-utilized.

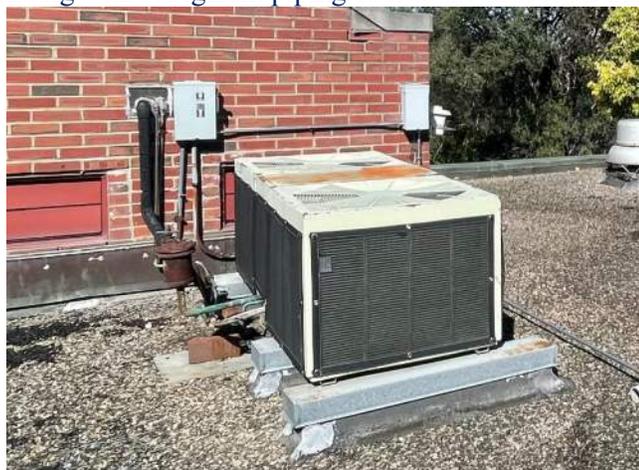
***Figure 10: Roof Mounted DX Cooling Unit***

The air handling unit provides heating with a hot water hydronic coil served by the boiler heating system. Cooling for this unit is provided by a DX (direct expansion) roof mounted unit located on the 1964 addition portion of the building with refrigerant piping over to the indoor air handling unit.

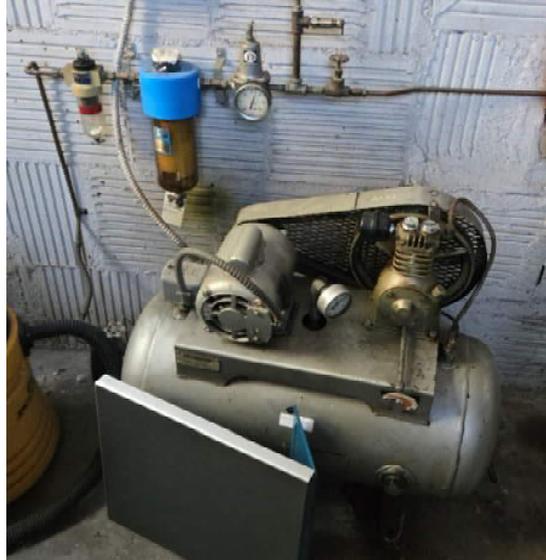
*Figure 12: Air Compressor for Pneumatic Controls*

The building has an antiquated electronic and pneumatic control system that appears to be partially disconnected and no longer in operation.

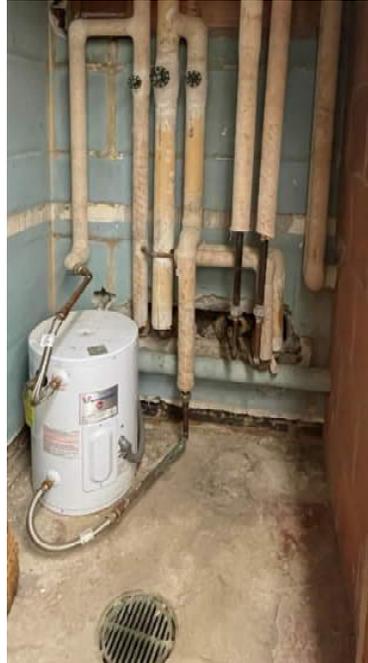
*Figure 14: Electric Water Heater*

The building hot water demand is being served by a 10-gallon Rheem tank type electric water heater. The unit was manufactured in 2004 and serves the (4) lavatories in the restrooms. Currently there are no thermostatic mixing valves installed to temper the hot water at the lavatories (as required per MN plumbing code), and the domestic water and sanitary waste piping are not protected as required per ADA standards. Both items need to be addressed should these bathrooms be utilized in the future.

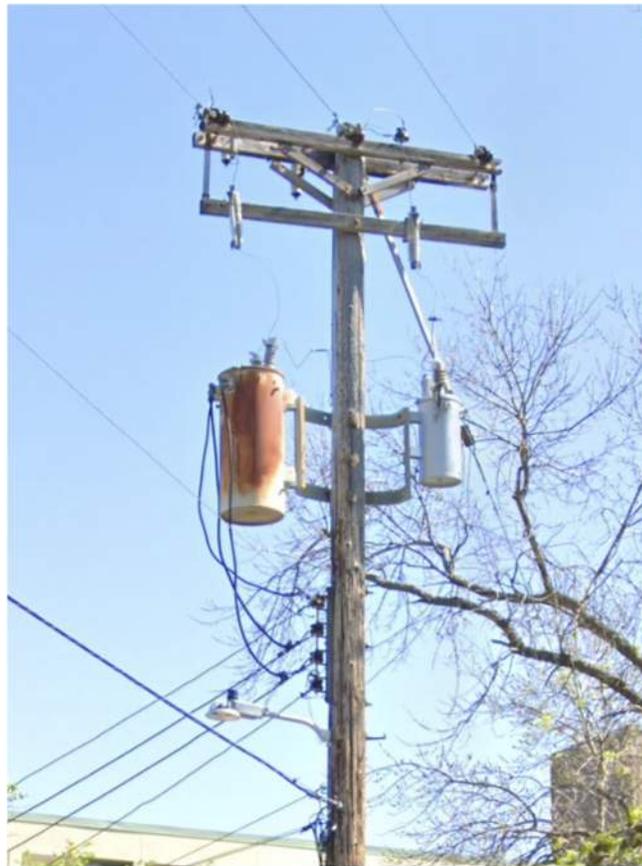
The South St. Paul Library is being served by (2) pole mounted transformers that enters the building overhead via weather head. The electrical service is an open delta high leg 240/120V, 3 phase, 400A system; with the high leg being 208V line to neutral. This service configuration has been discontinued by most utilities due to load balancing complications and confusion with the high leg. The service size appears adequate for the building.

*Figure 15: Pole mounted utility transformers serving the building*

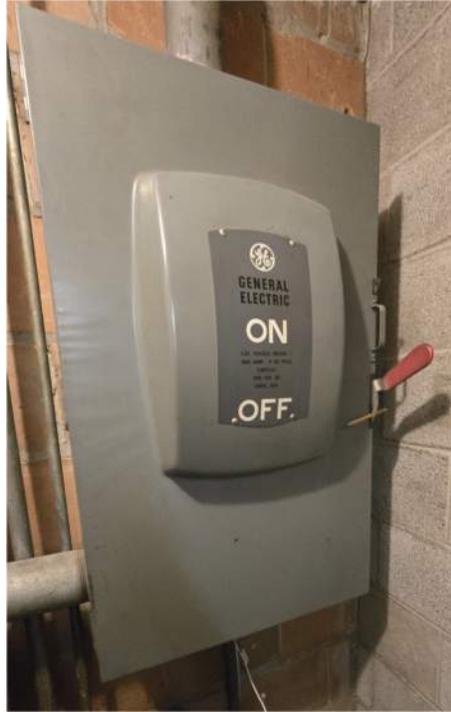
The electrical service equipment is a 240V, 400A, 3-pole disconnect switch. There is no indication that this disconnect is rated as an acceptable service entrance disconnect. This is not compliant with NEC 230.66(A), and 230.70(B). Additionally, there is no indication that the service is a high leg configuration. This is not compliant with NEC 110.15. It was also observed that the disconnect on/off switch mechanism is broken. A pencil has been inserted into the mechanism to keep the switch in the “on” position. See figure below. A standby generator was not observed at this facility.

*Figure 15: Service Disconnect without label or high leg indication*

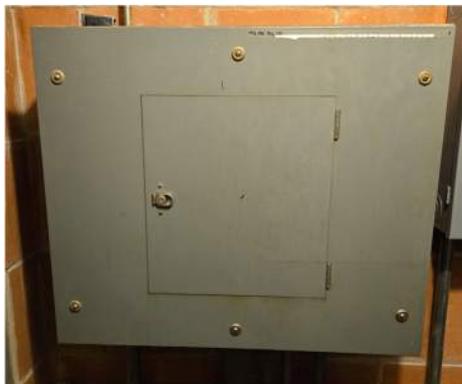
In the main electrical room, the service equipment appears to feed a Kinney 240V, 200A, 3-phase distribution panel. The panel does not have any name indication or equipment label. According to the circuit directory, it has a 200A main breaker and serves most of the large mechanical equipment. The panel appears to have (6) spaces available for expansion. However, due to its age replacement breakers could be scarce and unreliable as the manufacturer discontinued these breaker types. The indication of a high leg is not present on this panel. Panel is shown below.

*Figure 17: Distribution panel with no name or high leg indicated*

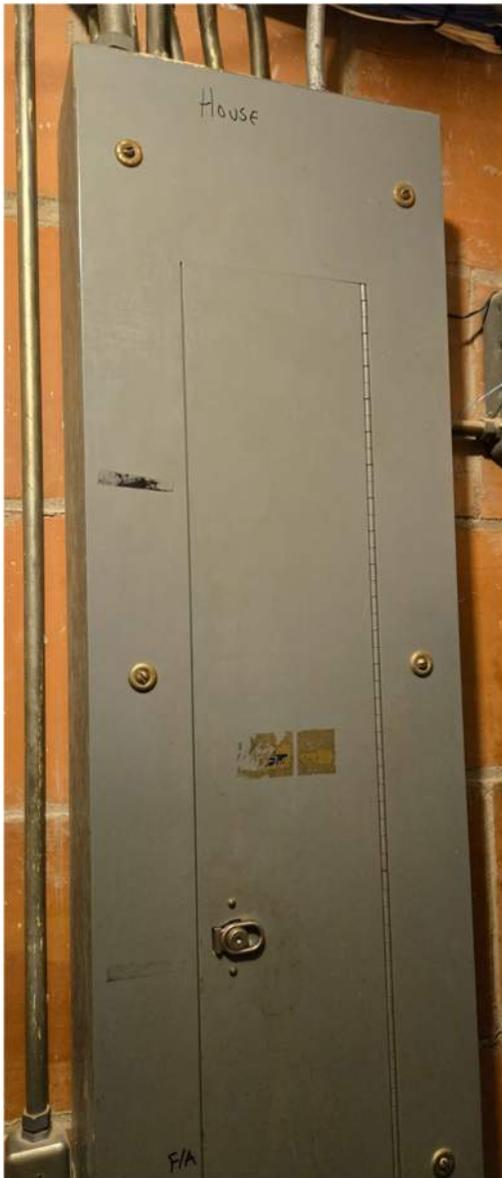
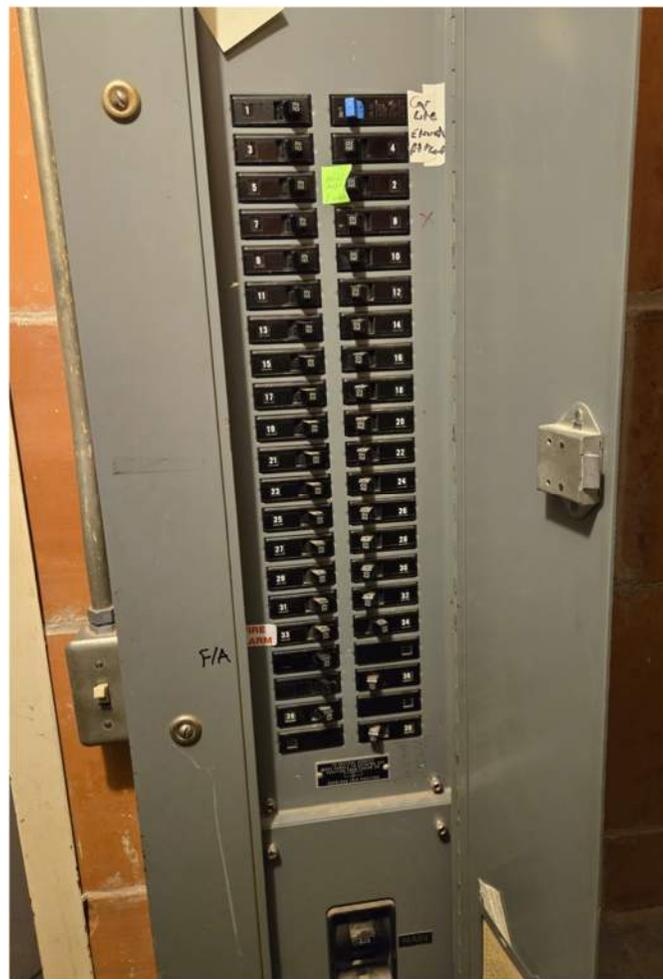
In the same space, there is another distribution panel that is labeled “House” in permanent marker on the cover. According to the equipment tag, it is a 240V, 225A, 3-phase panel with a 225A main circuit breaker. The panel appears to be functioning properly; however, it is nearly at breaker space capacity as there are 3 slots available for use out of 42. The circuit directory is handwritten and only indicates circuits 1-21. Circuits 22-42 are unidentified. Additionally, there is no indication of the high leg on this panel. Panel shown below.

*Figure 1816: Panel “House”*

*Figure 19: “House” Panel interior*

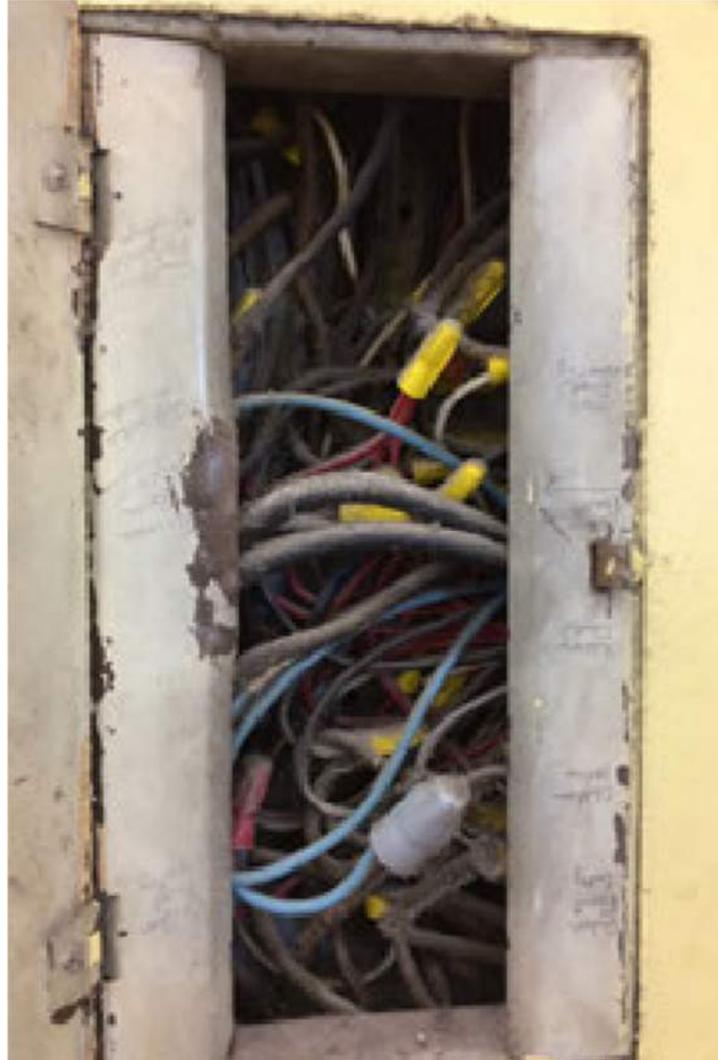
It appears that panels have been replaced in the past as an existing panel enclosure is now being used as a junction box. Visual inspection of the junction box revealed that cloth insulated wire was still in use. Cloth insulated wire was a common insulation type prior to the 1960's and is no longer installed within buildings. The insulation degrades much faster than modern rubber/plastic insulation and can pose a fire hazard.

*Figure 20: Existing panel enclosure being used as a junction box housing cloth insulated wire*

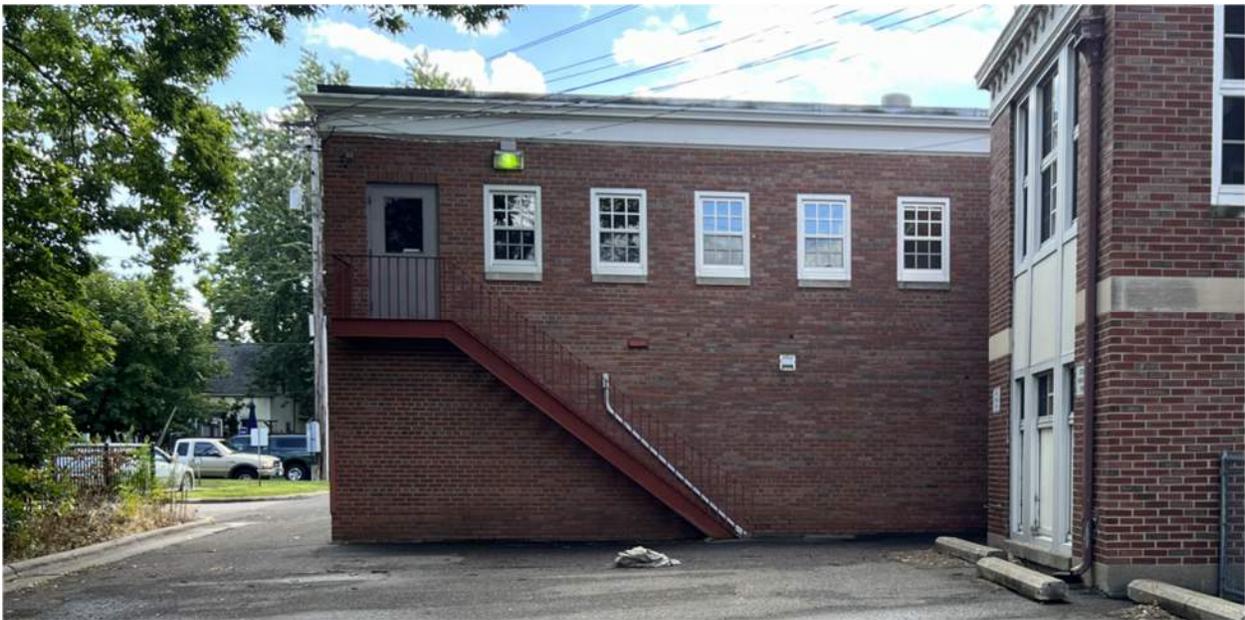
Exterior lighting has several building mounted fixtures. The fixtures appear to be weathered and aged. The fixture serving a set of stairs, and a parking lot was observed to be on during the daytime; indicating that the controls are not functioning correctly. Night-time lighting was not assessed.

*Figure 21: Building mounted light serving stairs/parking*

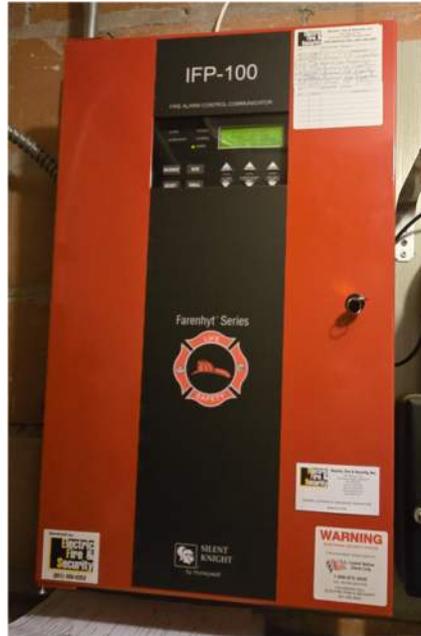
The existing fire alarm system indicates that it has been installed in 2014. Upon visual inspection the fire alarm system appears to have been serviced regularly and is within its useful life expectancy. Fire alarm panel shown below.

*Figure 22: Fire alarm panel in good condition*
