ARCHITECTURAL BUILDING ASSESSMENT - AMERICAN LEGION MEMORIAL LIBRARY

Date: November 22, 2024
Written By: Katie Kuisle, kuisle@newhistory.com
For: The City of South Saint Paul

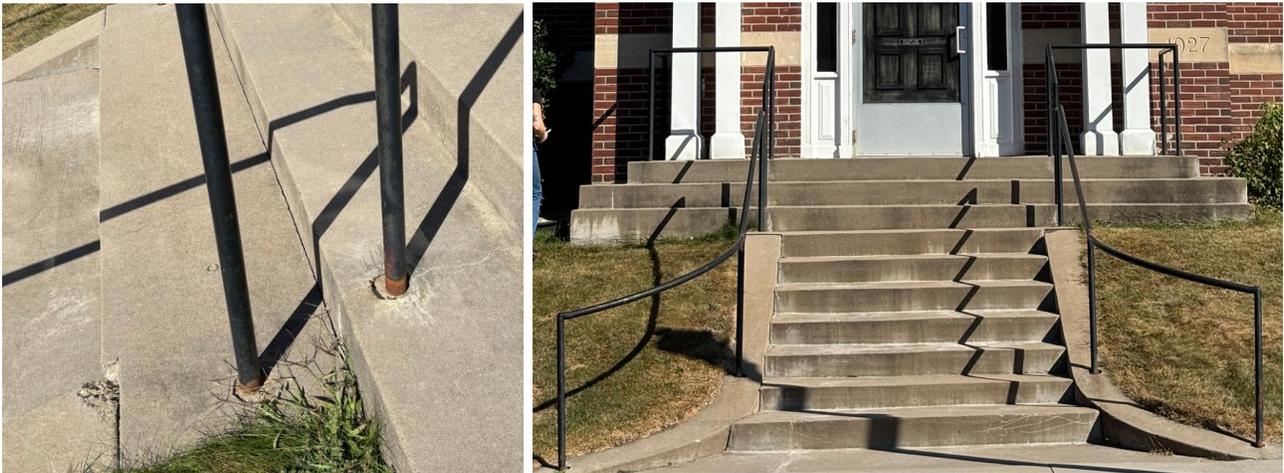
1927 - At the main entrance, the concrete stairs are relatively plumb and in tact. There is minor cracking and chipping at the corners and anchoring of handrail posts. This entrance is not ADA accessible.

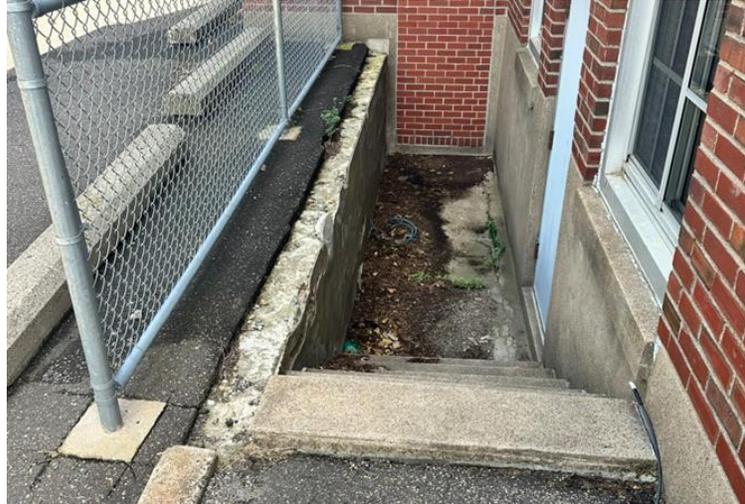
Concrete wall and stairs at egress from lower level, on the east side of the building, are in poor condition. No handrail present. Fall protection is mitigated with a chain-link fence. Slab at the base of the pit is cracked and stained. According to the “Dakota County South St. Paul Library” report, the drain is insufficient and water often infiltrates the lower level. Walking surfaces are not flush and present a potential tripping hazard. This is not an accessible entrance.

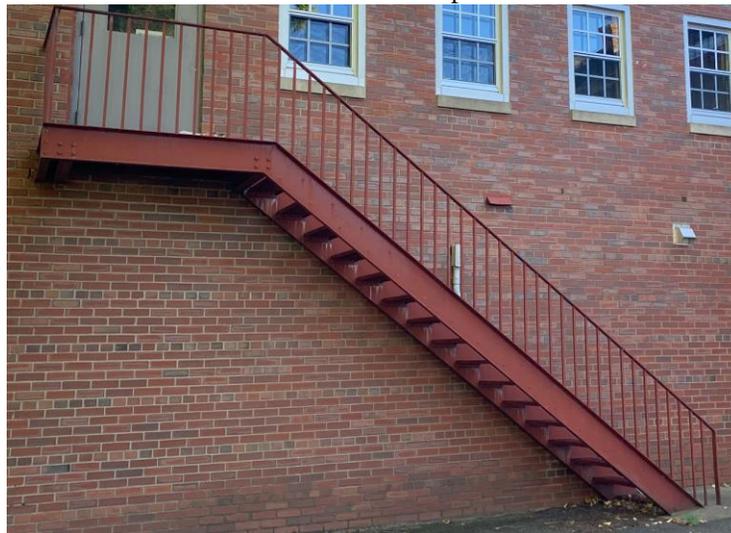
1964 – Exterior steel stair to level 2 in acceptable condition. The finish could use a refresh. Railing/Guardrail does not meet code. No handrail present at brick wall.

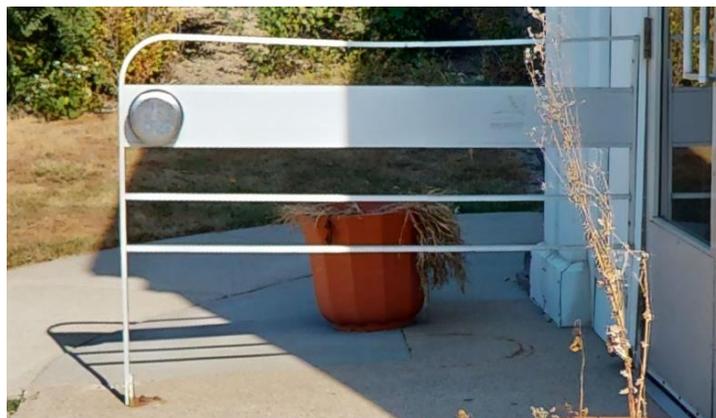
ADA actuator at main entrance is bent on the top rail, and rusted at the bolted base condition. According to the Dakota County South St. Paul Library Study, it has reached the end of its useful life.

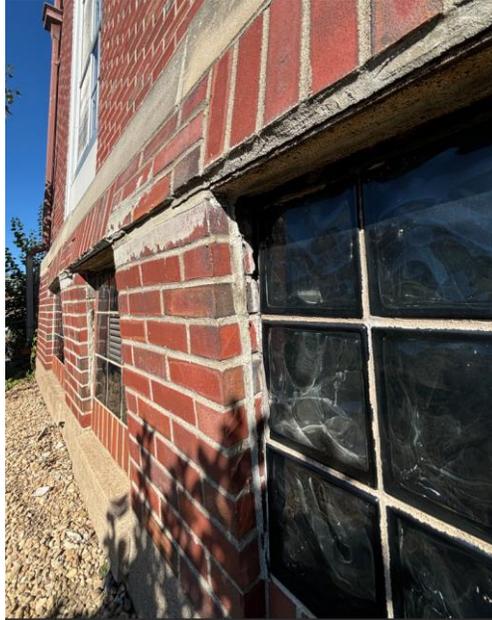
The primary issue evident at these walls is the failure of the brick face, where water has infiltrated the façade, creating rust-jacking at the steel lintels and causing the finish brick to fall away from the structure. Typically this is isolated to the 1927 portion of the building below level 1.

The worst case of rust jacking and damage to the brick at the west facade

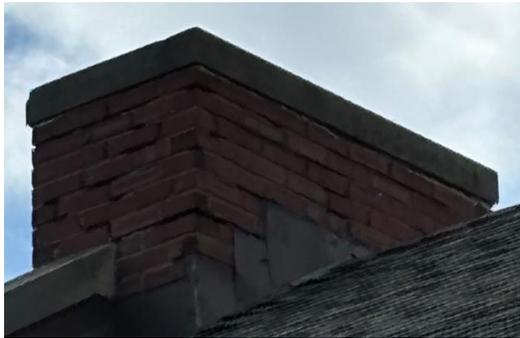
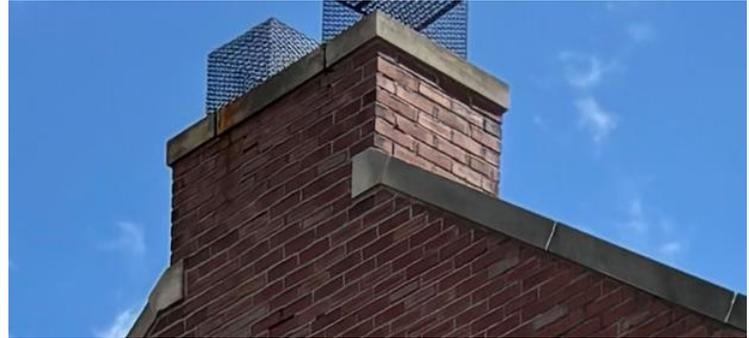
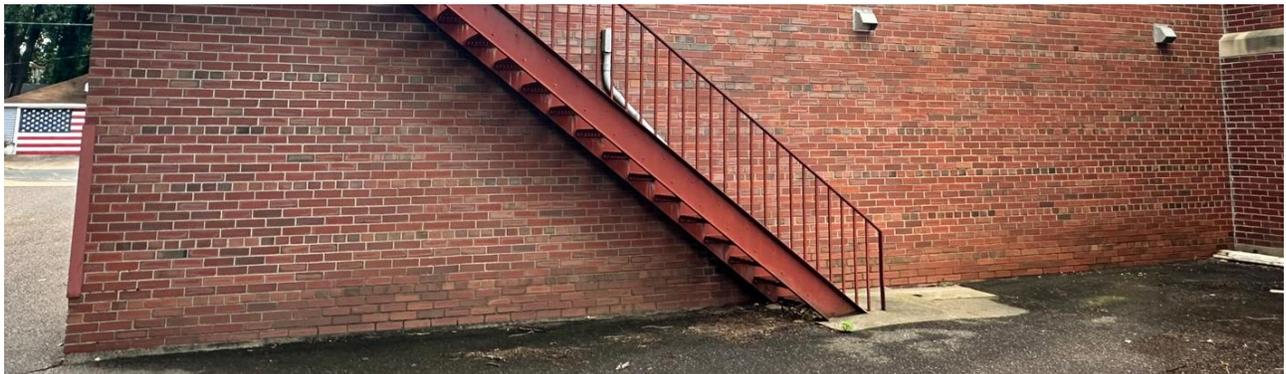
Brick and mortar at the upper portion of the building, particularly at the chimneys, and the brick in the splash zone, requires repointing.

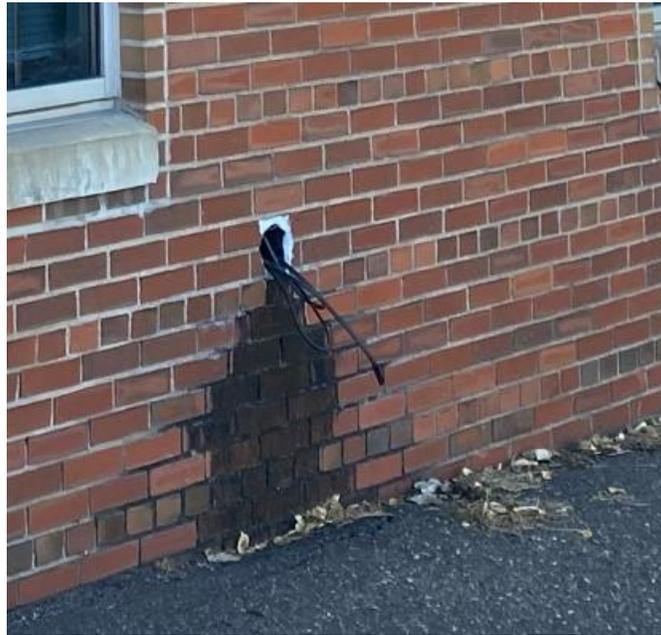
Brick is stained and/or discolored below mechanical penetrations and should be non-abrasively cleaned. At this location, on the east side, there is no downspout nozzle.

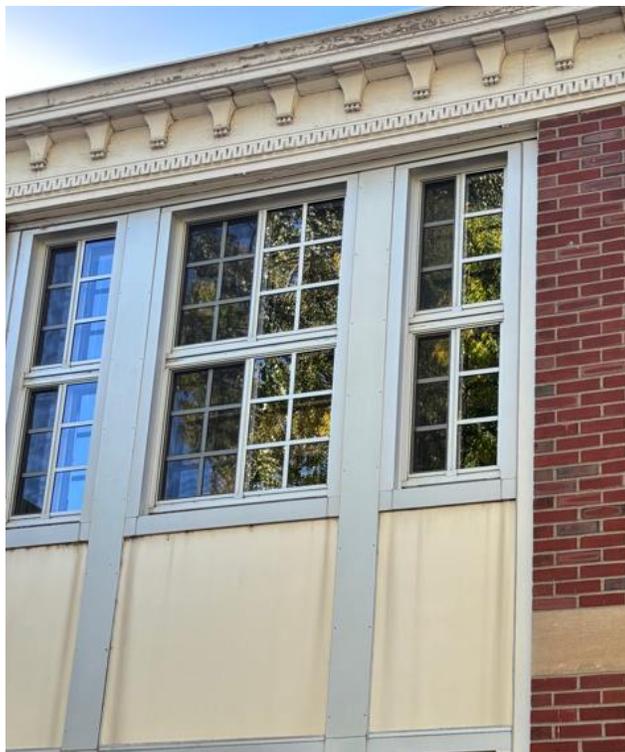
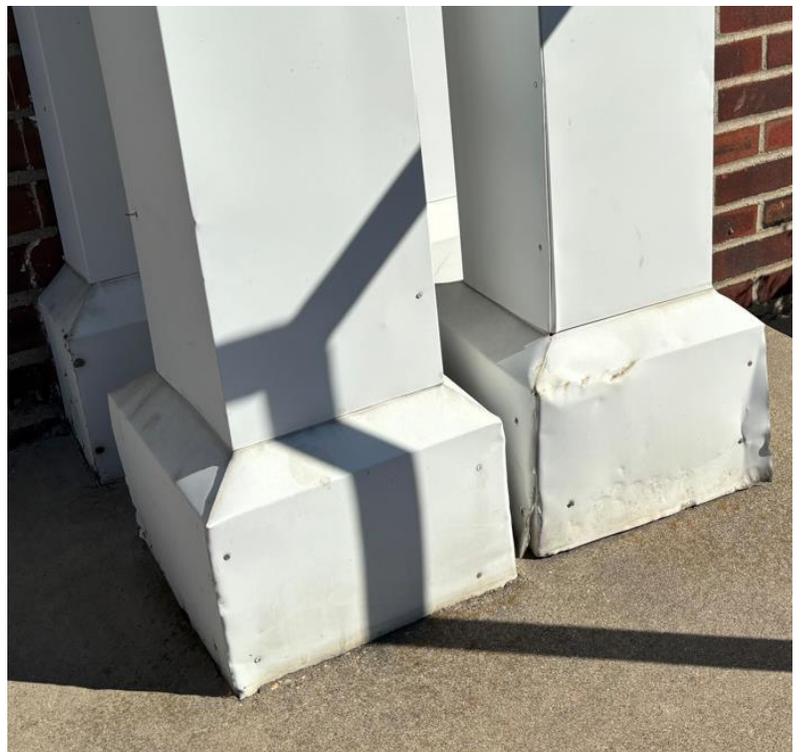
Aluminum cladding that was added over the original wood elements is showing signs of water staining and rust. There are gaps and deterioration at joints and corners.

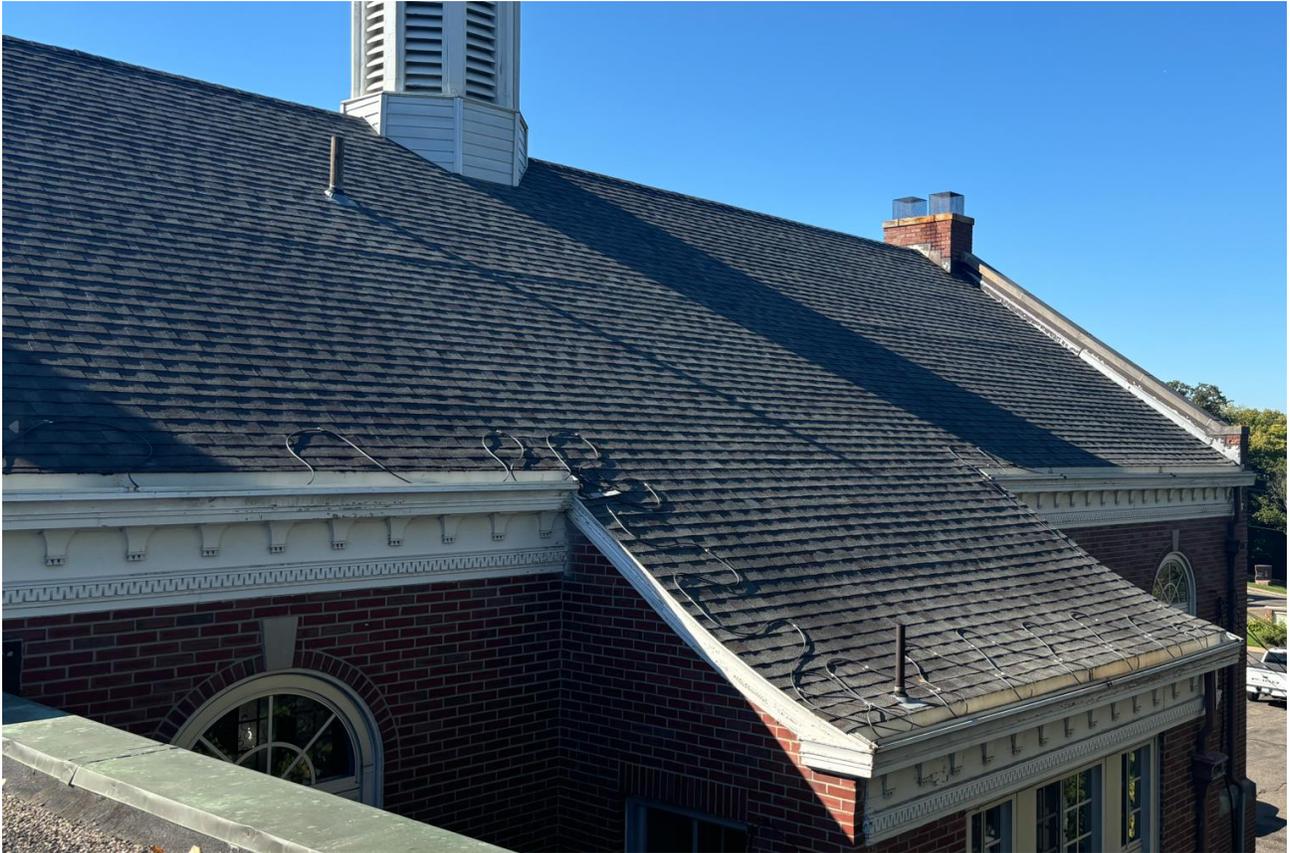
1927 - The asphalt shingles atop the gabled roof are fair to good condition. Replaced 20 years ago - this roof is still within its useful life. Prefinished metal flashing is also in fair to good condition. Original wood trim is showing signs of wear, occasionally beyond the surface scaling, and should be filled and repainted.

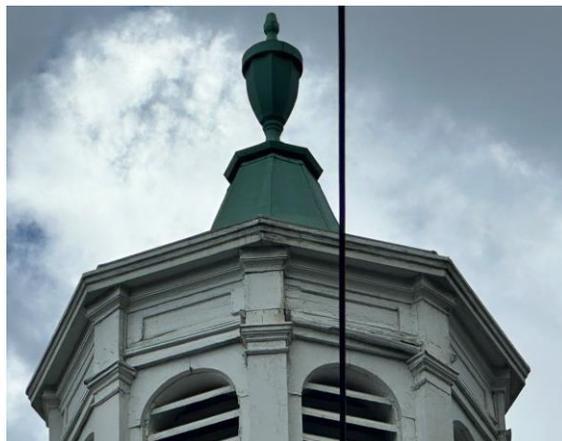
Wood trim on the east side of the cupola is showing further signs of decay and may warrant replacement.

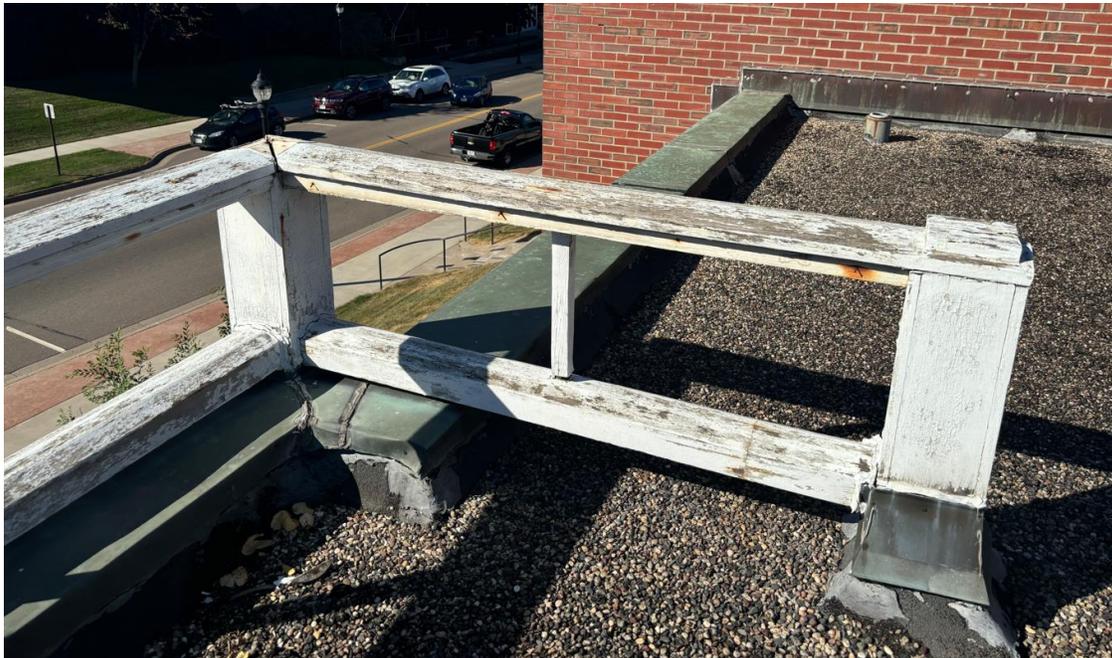
1964 - According to the facility maintenance team, the flat, ballasted roof leaks and a comprehensive replacement is needed. The railing is in poor condition, missing many of the original finials and does not meet any of the required code requirements for occupancy at the roof. The metal flashing at the wall caps is sufficiently in tact.

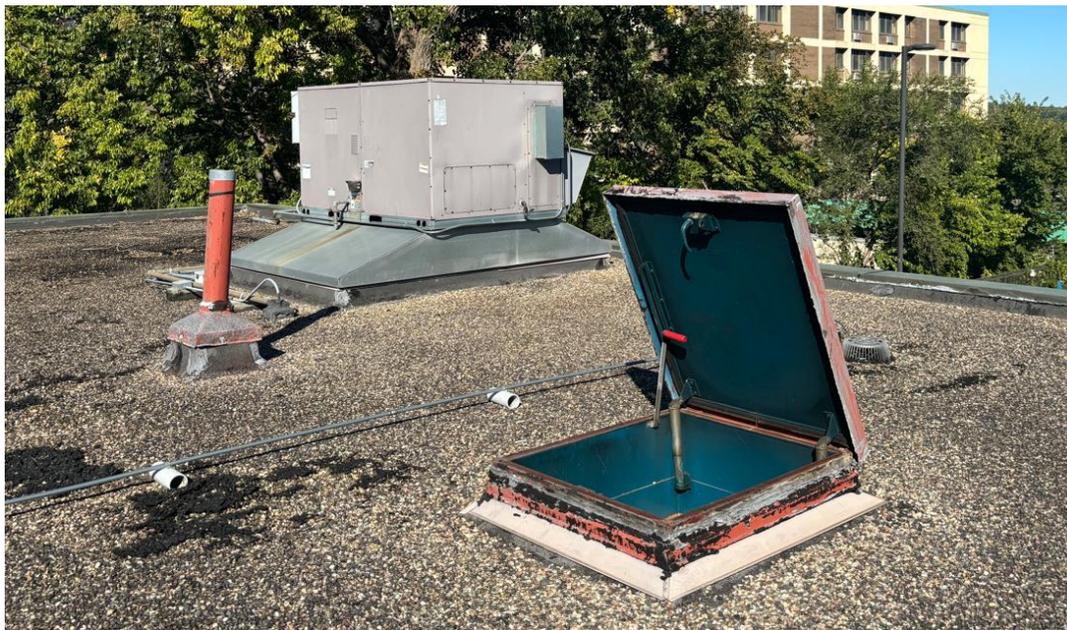
Roof hatch is functional. Mechanical Equipment is past its useful life as detailed in the mechanical portion of this condition assessment.

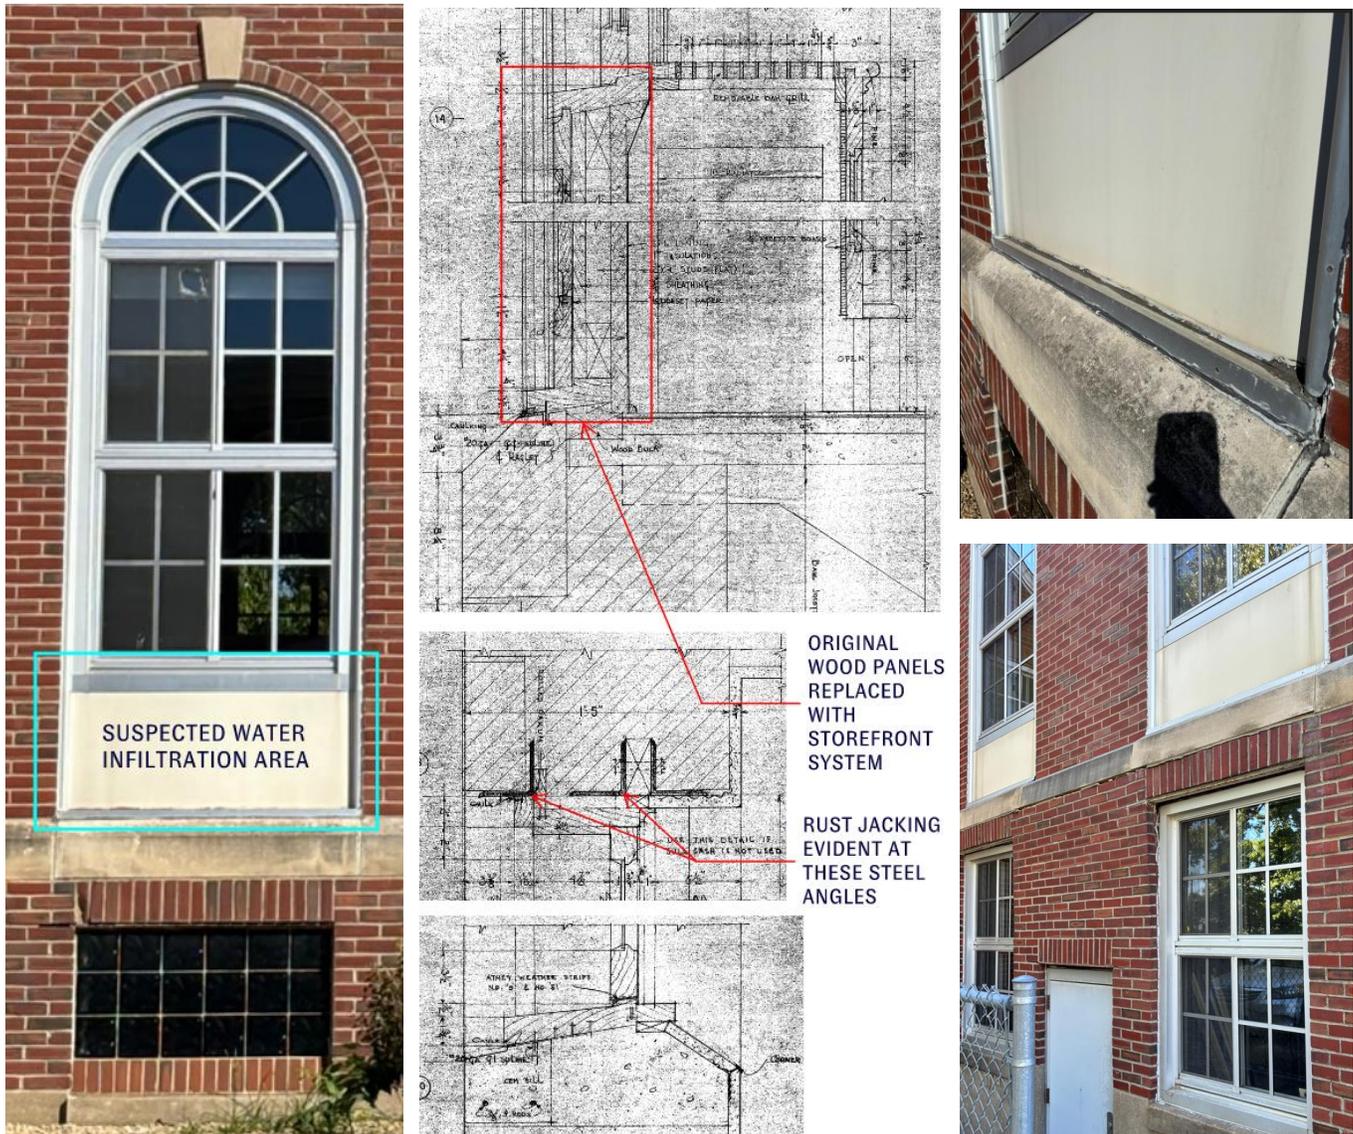
The windows are not original at either building, most having been replaced in 1980 with anodized aluminum-framed dual-layer, single pane storefront system. Water infiltration is evident in the walls below each of the modified windows within the 1927 portion of the building. The suspected site of vulnerability is within the spandrel panel beneath the 1980's glazed systems.

While improper installation is suspected at the windows within the 1927 portion of the building, the aluminum frames and glass throughout are generally in good condition, and repair is limited to needing new sealant and screens where damaged.

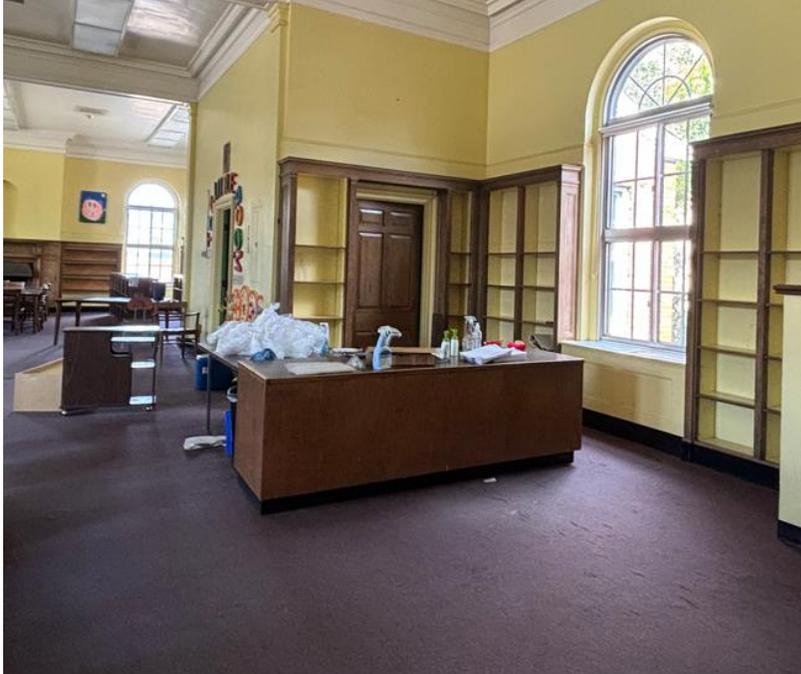
1927 – Older carpet in poor condition and original slate base in good condition.

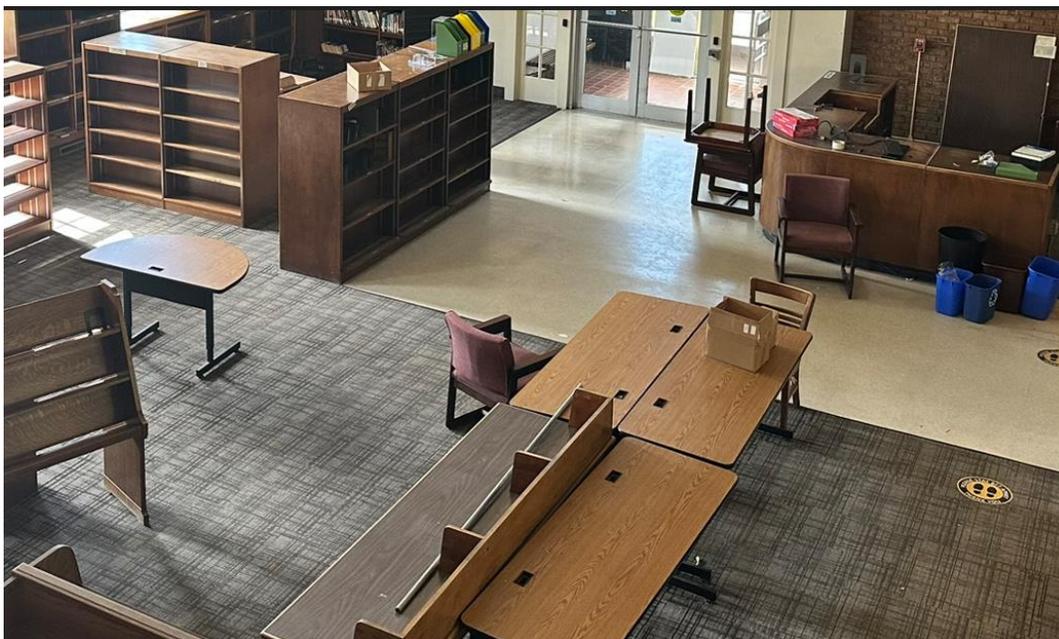
1964 – New carpet within the main reading room, older carpet at the mezzanine, exposed concrete at the reception area, and tile at the entrance vestibule and tile at the restrooms.

All floor finishes except that of the main reading room in the 1964 addition are in poor condition. The flooring layout is highly correlated with the former program of the spaces.

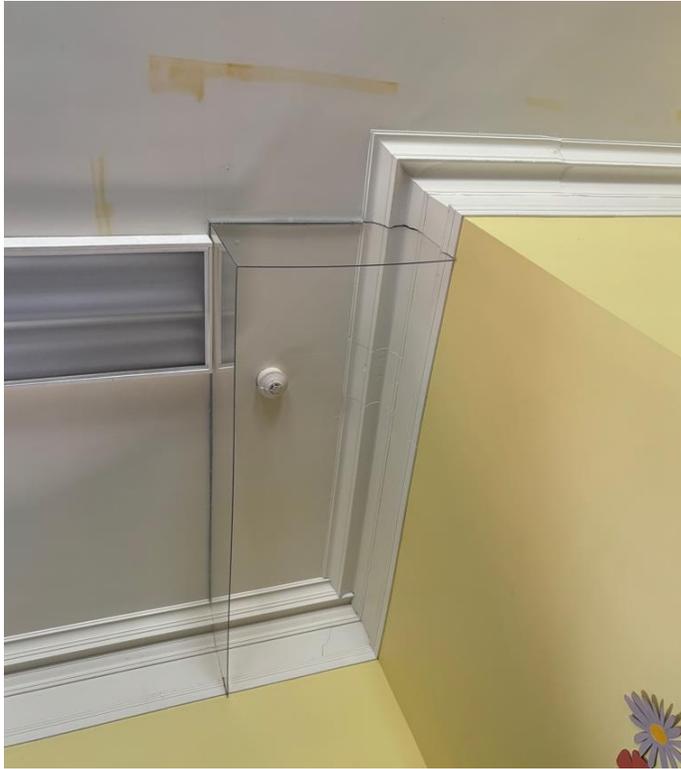
1927 - Ceilings within the older portion of the building are plaster with wood cornice. Some surface cracking present. Generally the plaster and cornice is in good condition with the exception of the area around the elevator where a smoke guard was added.

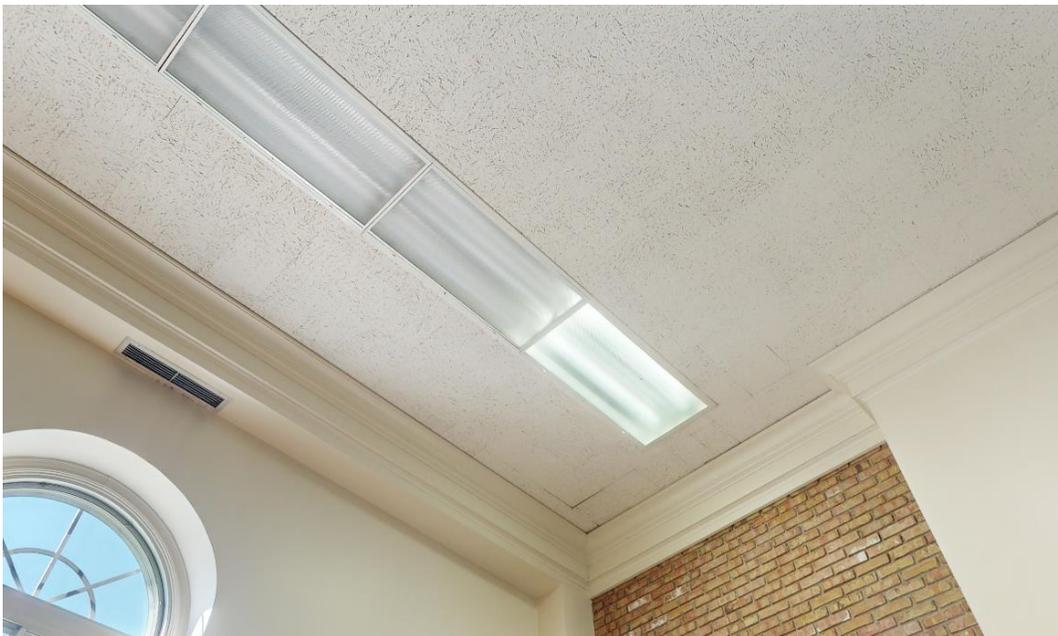
1964 - Suspended Acoustic Tile (ACM) with wood cornice at the reading room, and plaster ceilings at mezzanine. Some staining present within ACM.

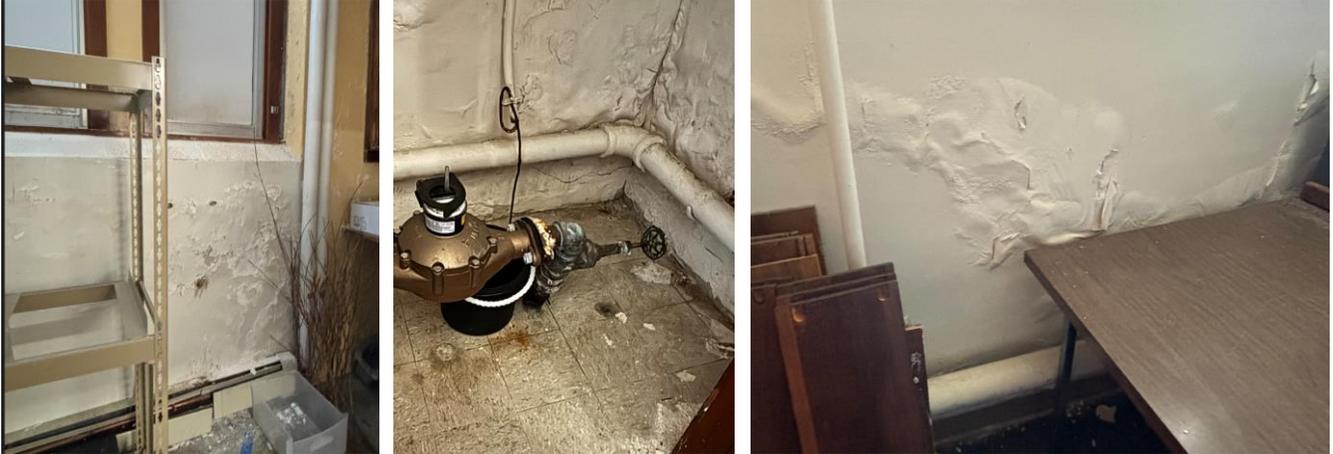
1927 – Per the original construction drawings, the interior partitions at the lower level of the building, are clay tile. At level 1, they are wood. The wall finishes at the exterior of the lower level show significant signs of water infiltration and effervescence

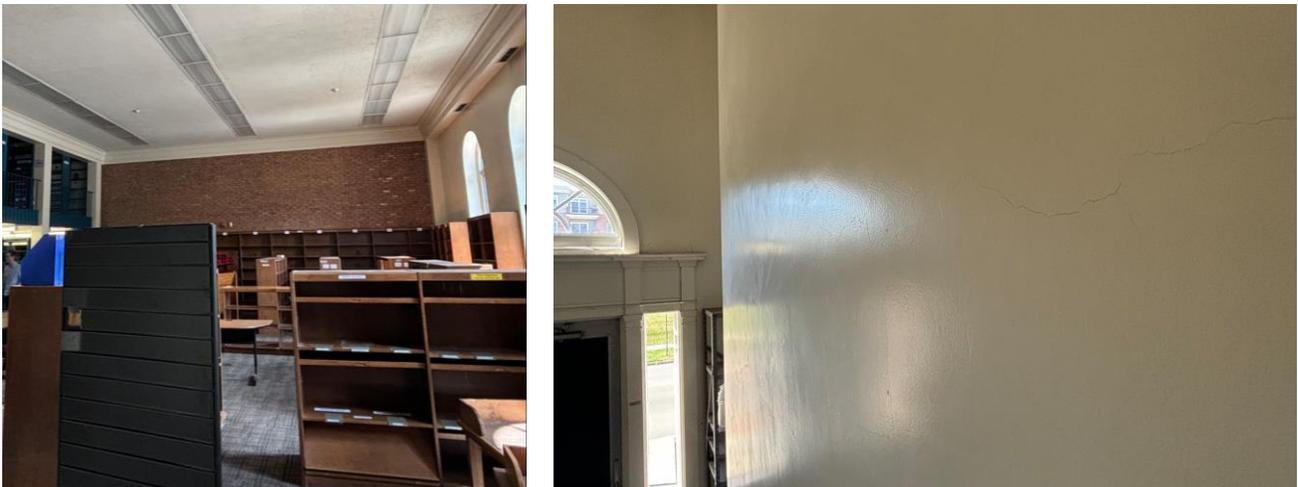
1964 – Per the original drawings, the interior partitions are a combination of masonry units and tile. The plaster finish and paint throughout both buildings is largely in tact but shows visible signs of wear, particularly at corners and areas where wall hangings were. In some locations, the masonry is left exposed.

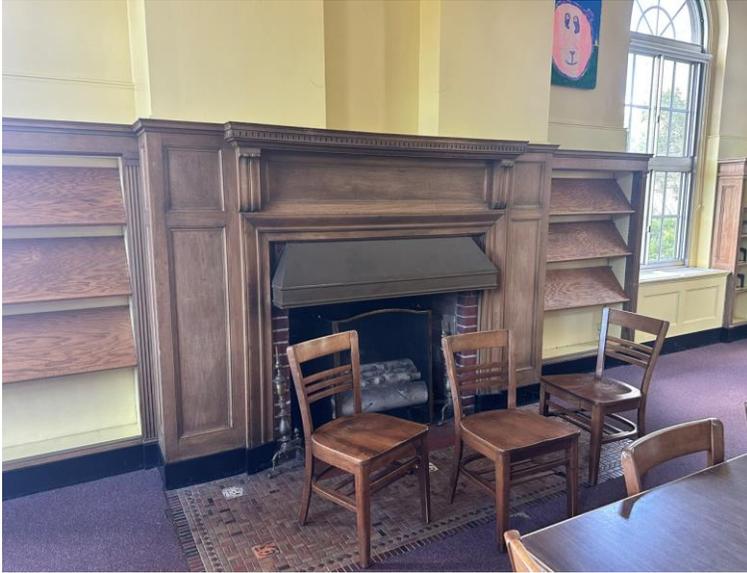
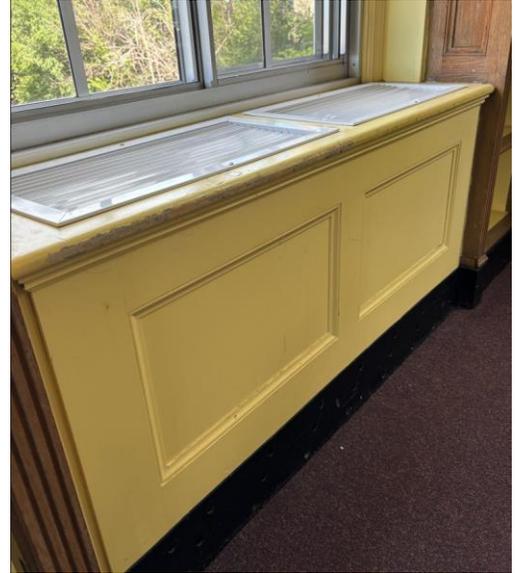
Many of the built-in wood elements pass muster as character-defining features of the space. While in acceptable condition, much of the shelving is a veneer that shows signs of delamination and requires repair. Solid wood trim as seen at the cornice and railing balusters in the lower level is in much better condition. Some minor damage present from intentional vandalism at radiator covers.

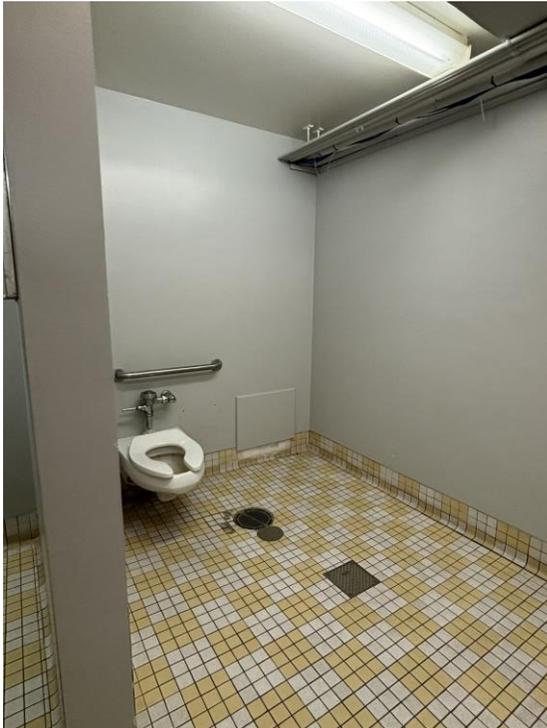
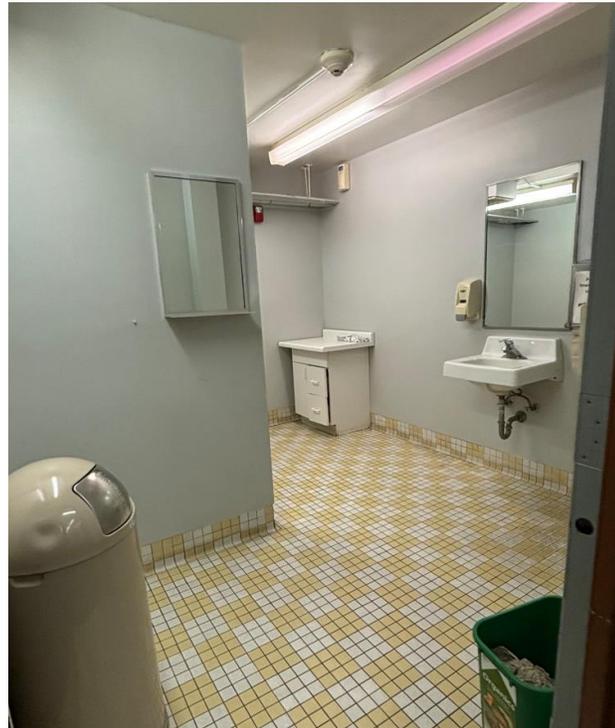
The restrooms are generally in poor condition, with cracked and missing tiles, ADA issues (grab bars, reach ranges, projections, pipe insulation, etc), yellowing and damaged toilet accessories, and exposed wiring In

addition to their current condition, the restrooms do not meet the counts required by code, they are not efficiently laid out.

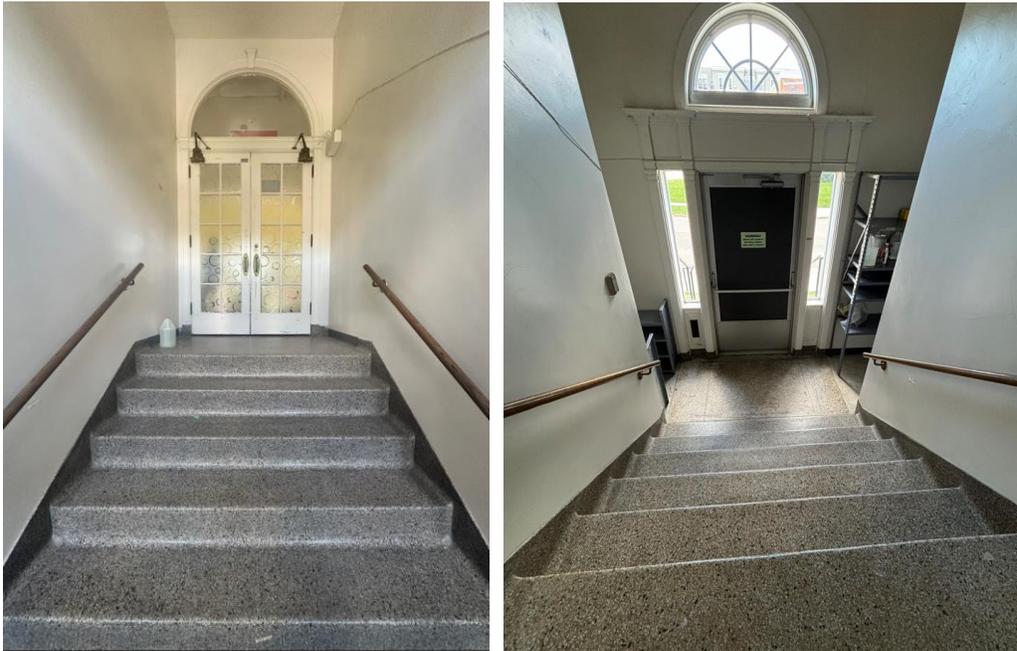
The main interior stair at the 1927 original structure is alarmed and no longer in use. The inaccessibility at this entrance appears to be the main driver. Original terrazzo treads are in acceptable condition but show signs of wear.

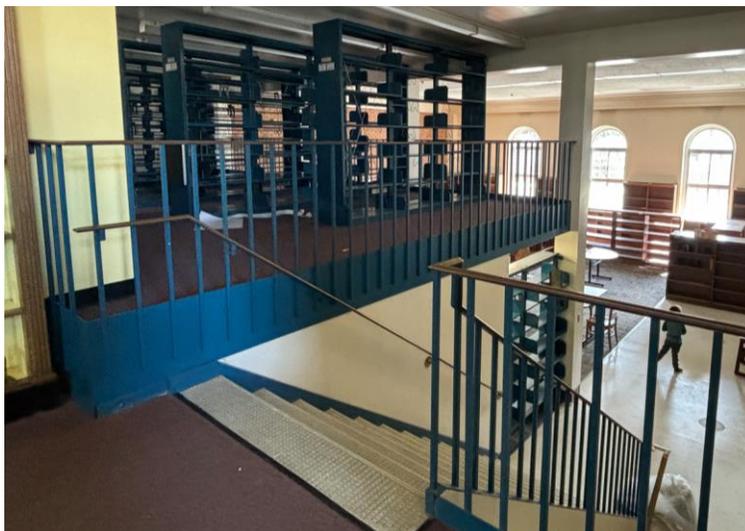
Gaps in the railing balusters at the stair and mezzanine perimeter are too wide per MNBC Section 1015.4

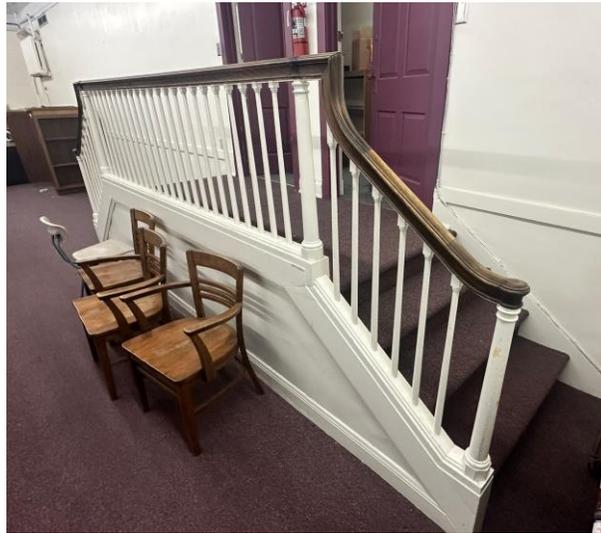
Stair access to the mechanical room at the lower level of the 1927 building is non-compliant. It does not provide an adequate landing, door approach of handrail extensions.

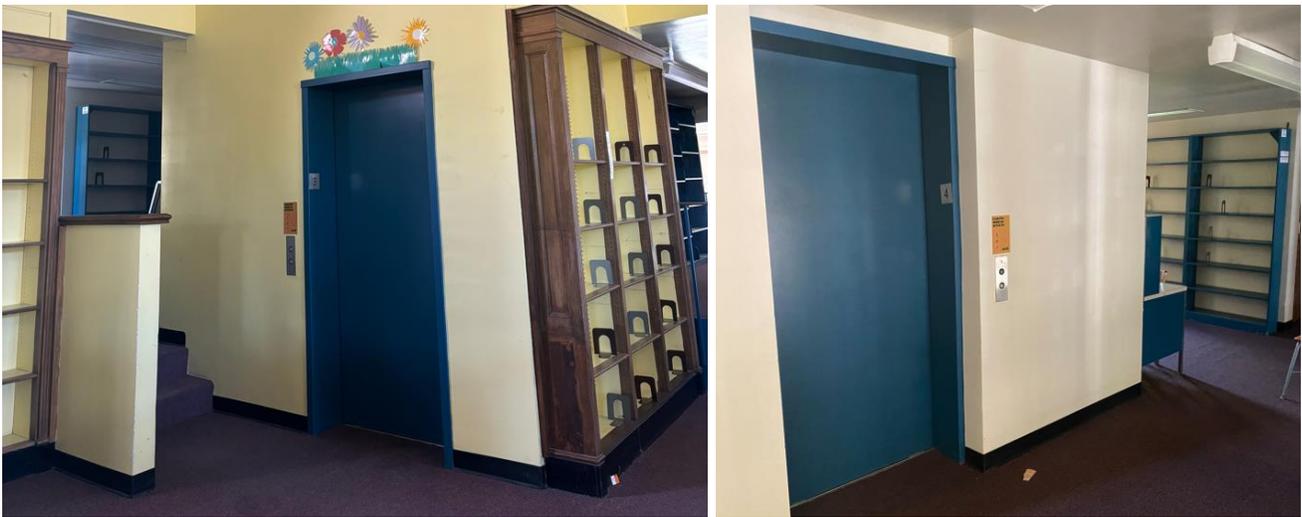
The elevator, which altogether has 4 stops, was added in 1996. Service records should be verified with facilities management and/or a licensed elevator inspector to assess the condition, maintenance costs, and compliance of the equipment and shaft.
