AMERICAN LEGION MEMORIAL LIBRARY ADAPTIVE REUSE FEASIBILITY STUDY

106 Third Avenue North
South St. Paul, MN 55075

May 30, 2025

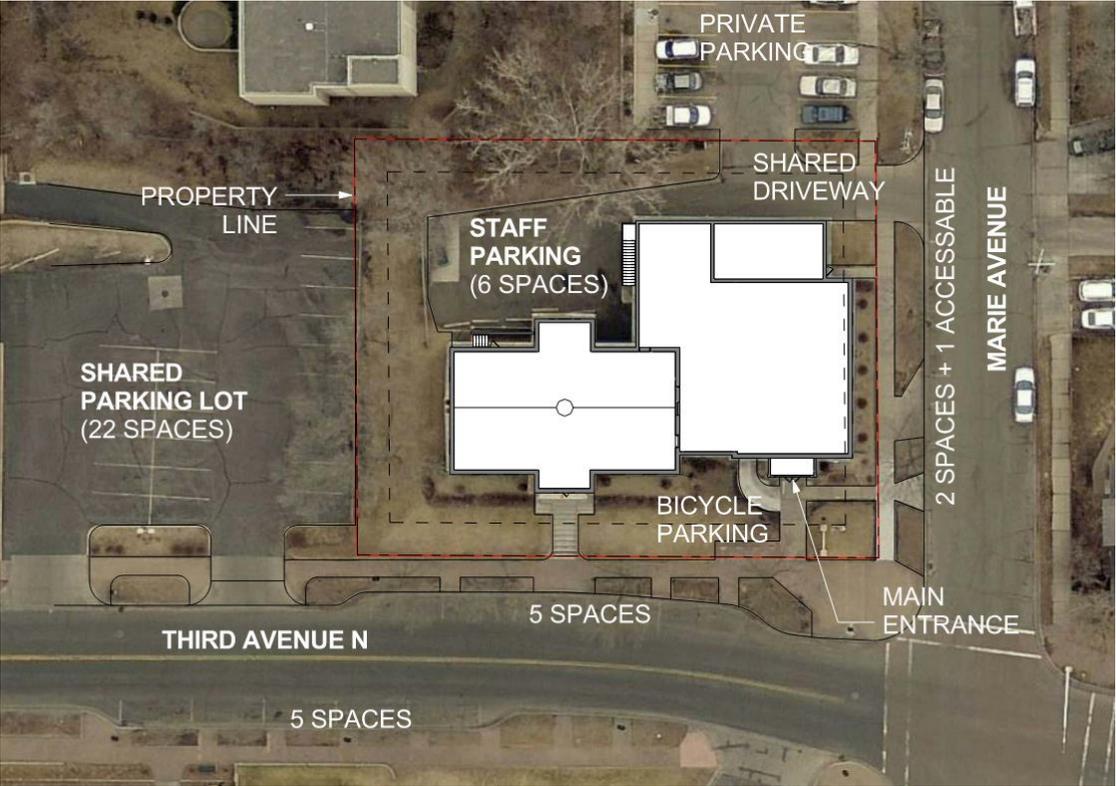
Site plan of existing conditions by LSE from the 2016 Library Assessment and Planning Study

The majority of the parcel’s existing site is in acceptable condition, but there are areas that may warrant improvements at the time of any reuse project. The parcel's Third Avenue North frontage is in acceptable condition, and it does not appear that improvements would be required. The existing sidewalk along the Marie Avenue frontage appears to be in acceptable condition, but the existing curb and gutter and pavement condition along Marie Avenue may require replacement or repair if the city requires half-width right-of-way improvements. The entrance to the library’s addition appears to meet accessibility (ADA) requirements, but the entrance to the original library does not currently meet ADA requirements with the absence of a ramp.

The existing pavement in the rear parking area appears to be in acceptable condition, but there appears to be issues with the current stormwater management that may be impacting the adjacent bluff and contributing to some cracking in the existing asphalt near the edge of the paved area. Repair of the existing curbing, and possibly the addition of a stormwater catch basin and piped connection to the lower parking area, may be required to successfully manage stormwater in that area of the parcel.

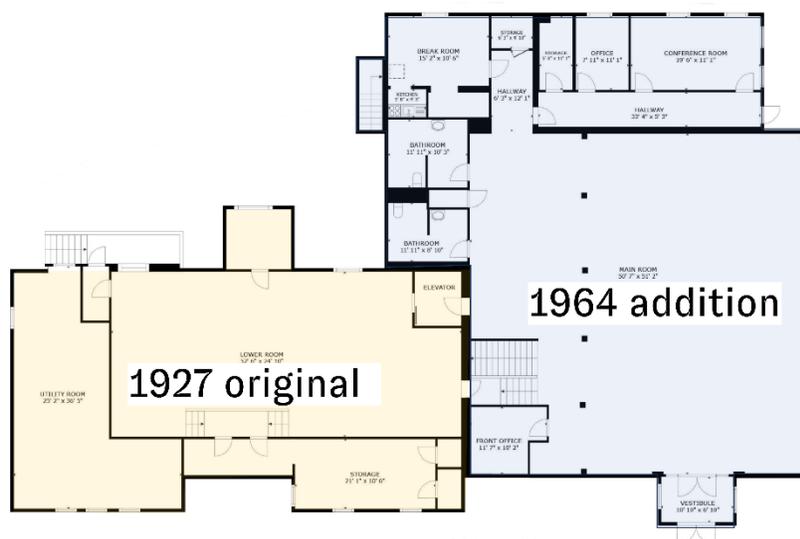
Figure 2: Diagram of First Floor, for reference (not to scale)

The single, central elevator was also added with the 1964 addition, and is currently in operating condition. Some occupancies, such as housing, may require modification to elevator cab sizes and even elevator shafts, prompting the need for elevator upgrades, replacement, or even a new elevator in a new location. Without a final occupancy decided, and with the potential that the existing elevator may serve the new use just fine, further details of elevator implications were not considered.
