# **CITY OF SOUTH ST. PAUL**

## **Memorial Library Reuse**

### **Feasibility Study**

CONDITION ASSESSEMENTS

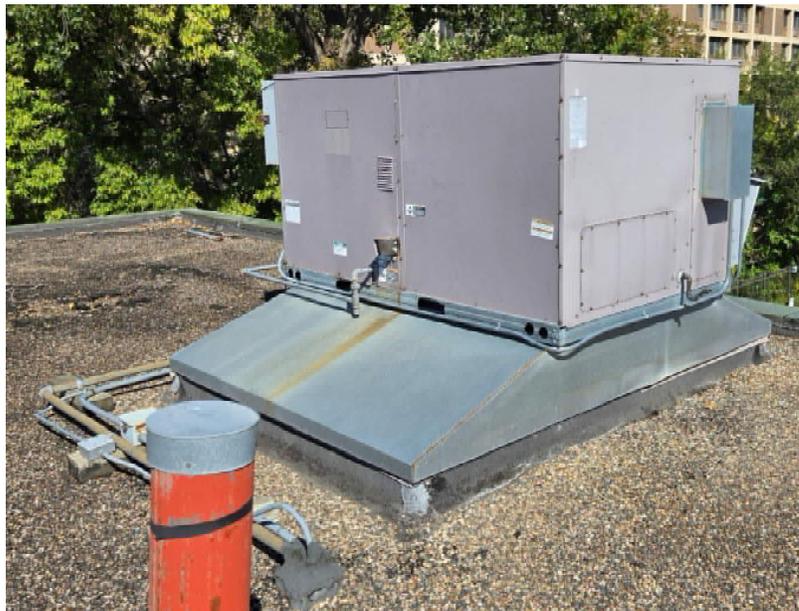
The rooftop unit serves the 1964 portion of the building and was installed in 2006. Ductwork is routed down above the offices and out to serve the office spaces and the 1964 portion of the open library. The ductwork is largely accessible except for the portion serving the open library area.

The rooftop unit provides heating via a gas fired burner and cooling via DX refrigerant integral to the unit. Ventilation air is supplied to the 1964 addition by this RTU.

*Figure 11: Rooftop Unit*

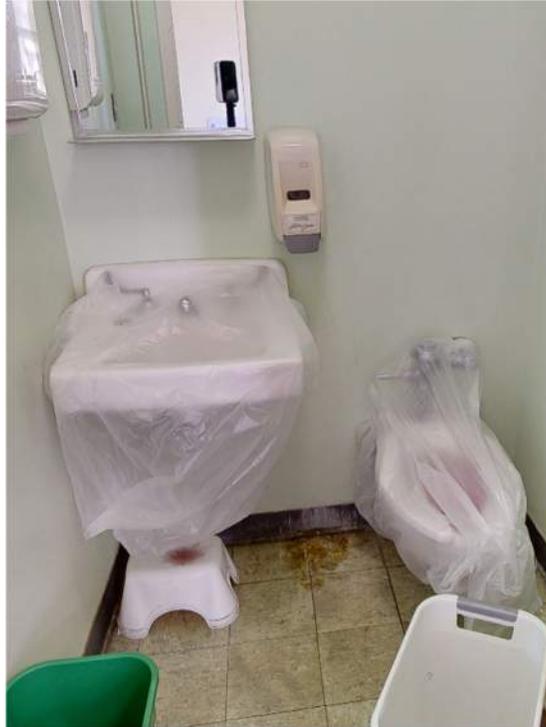
The building currently has (4) single-occupant restrooms and (2) janitors sinks. The single occupant restrooms each have a wall-hung toilet with a flush valve and a wall-hung lavatory sink.

*Figure 13: Restroom in 1927 Portion of Building*
