Marie Avenue Reconstruction Project – Phase 2

Feasibility Report

South St. Paul, Minnesota

City Project No. 2025-01

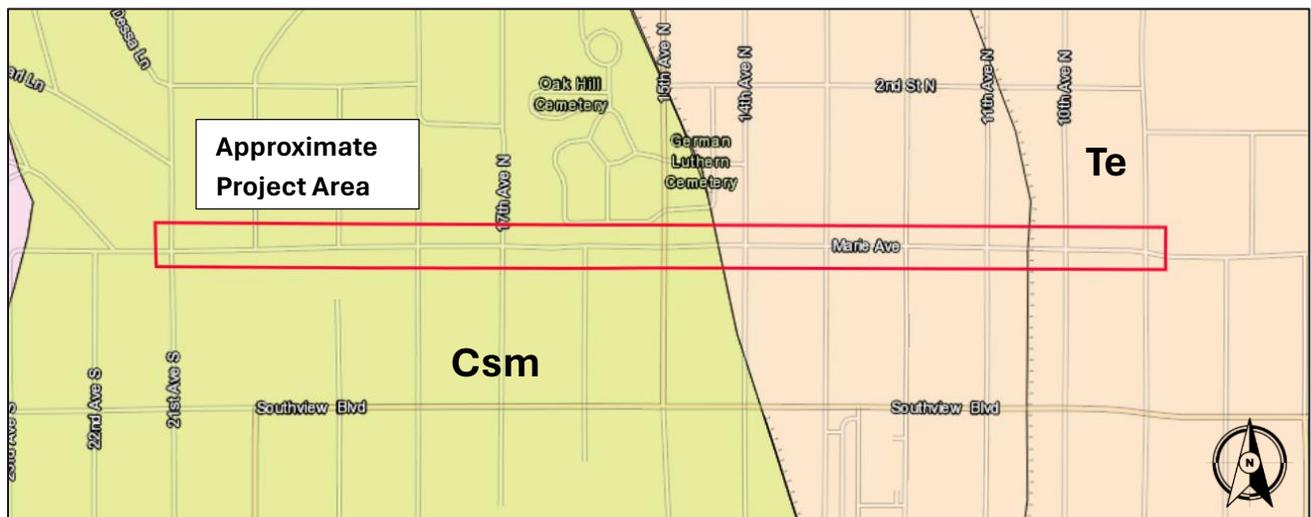
Figure 2-1. Surficial Geology of the Project Area

Figure extracted from Map C-57 from the Minnesota Geological Survey, Dakota County Plate 3.

Figure 2-1 depicts the surficial geology for the Marie Avenue reconstruction area (phases 2 and 3). The area is generally underlain by glacial till clays associated with the Cromwell Formation (map unit 'Csm'), and alluvial silts and sands, glacial outwash sands (map unit 'Te').

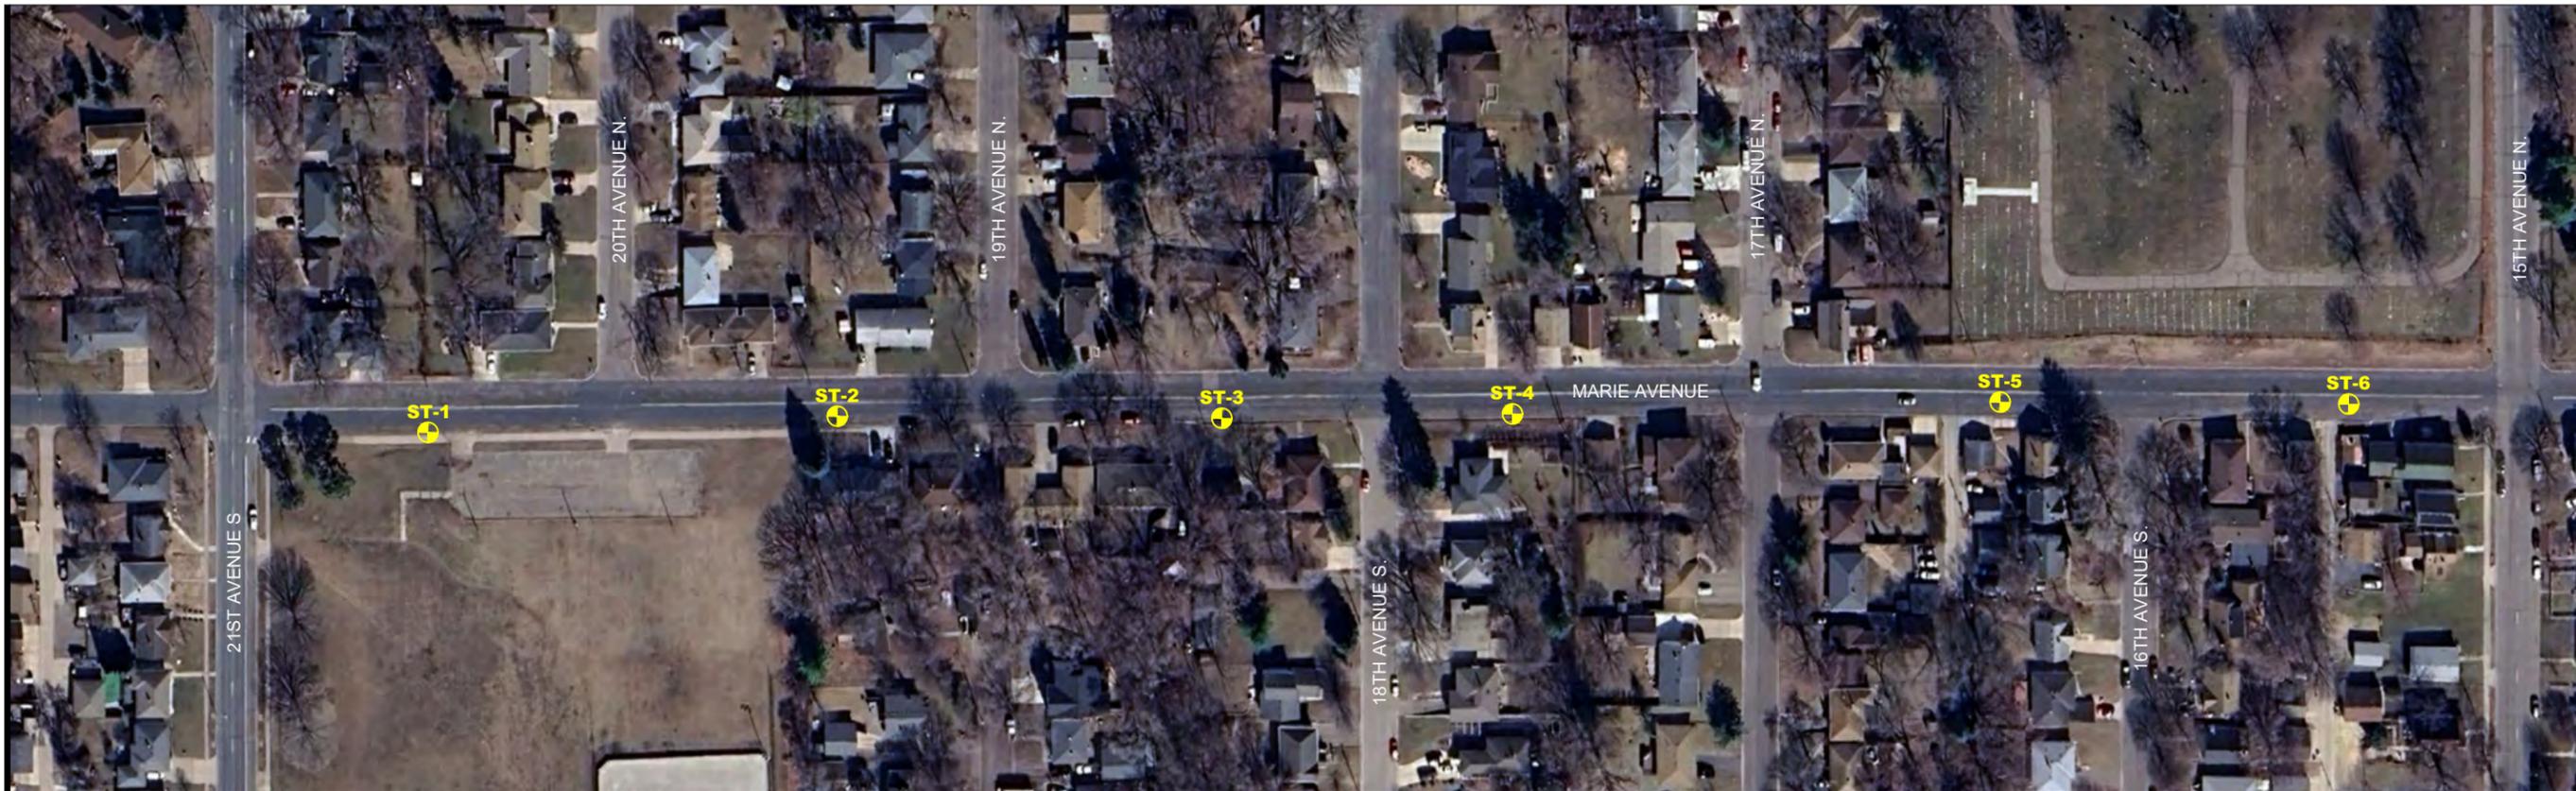
DENOTES APPROXIMATE LOCATION OF STANDARD PENETRATION TEST BORING
